WHOLE FLOOR WATERPROOFING OF BATHROOMS ON TIMBER FLOOR SUBSTRATE

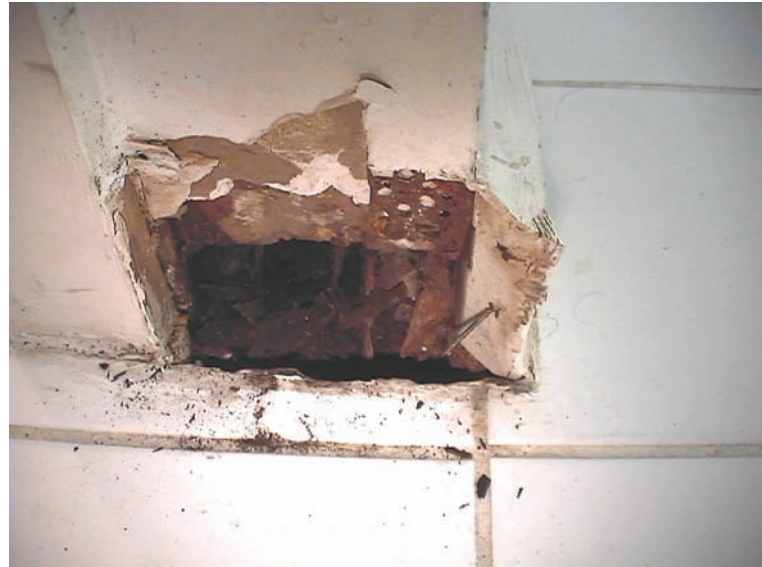
While there is no way one can control the shower screen door not being closed during operation, leaking shower screens is a continual problem. A typical example of damage caused by a leaking shower screen is shown in **Figure 1** where the bottom plate of the wall beside the shower has completely rotted away. In this case the shower recess used a pre-formed shower base but poor detailing of drainage at the base of the swing-screen door allowed about 30 per cent of the water draining down the

Figure 1 Water damage to bottom plate of separating wall

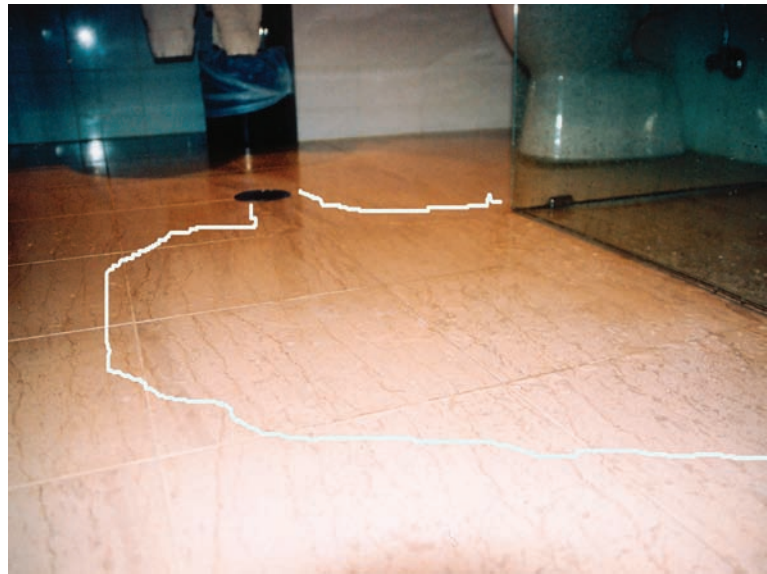
Figure 2 Water flow from under a frameless-glass shower screen door

Figure 2 shows the extent of leakage from one of these frameless-glass screen doors after a four minute shower. There was sufficient leakage that water was flowing down the floor waste in the general bathroom area before the four minutes of the shower had been completed.

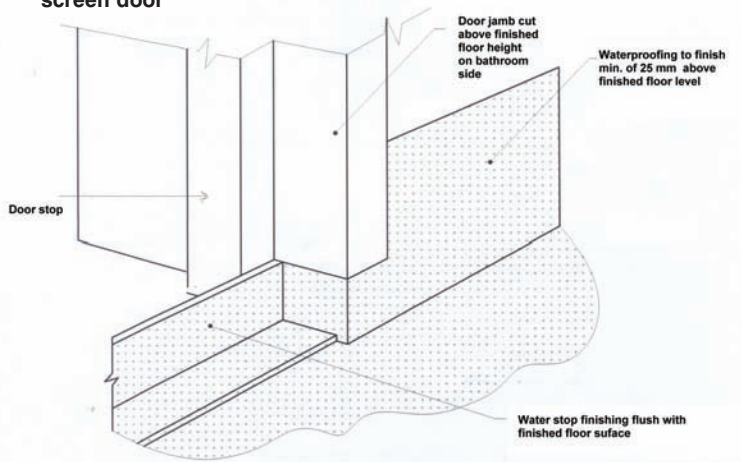
Figure 3 Water stop installation at doorway

With whole-floor waterproofing there is the requirement that a water stop is installed at the doorways into the bathroom. Two details are included in AS3740: one is where it is installed prior to the installation of architraves and doorstops, the other is after their installation. The preferred option is for the water stop to be installed prior to the architraves and doorstops as shown in **Figure 3**. The main problem with the detailing of this doorway water stop is that the water stop needs to finish flush with the finished level of the floor surface. Often the waterproofer may not have the information required to set the top of the water stop at the correct height. One way of overcoming this problem is for the Waterproofer to install the water stop below the expected height of the finished floor level and the tiler to extend it to the finished floor level height by either bonding an angle onto the water stop making sure that the bonding makes a watertight seal to the existing water stop, or fitting an angle on the outside of the waterproofing and making a watertight seal to the top of the existing water stop. This second method is not possible where there is carpet to be installed in the adjoining room, as the base of the angle extension would inhibit the installation of the finishing trim for the carpet.
