SEALING DECKS EDGE TERMINATIONS AND PENETRATIONS

By Barry Schafer

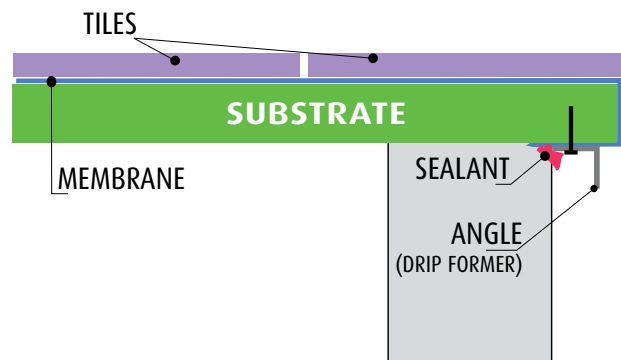
Not only can staining occur, but the water draining over the edge can flow back under the deck by water surface tension. The correct termination at the edge of a deck is shown in **Figure 2**. The angle section is sealed onto the membrane that is returned under the substrate sheeting using a sealant.

Figure 2: Correct termination at the edge of a deck using a drip former.

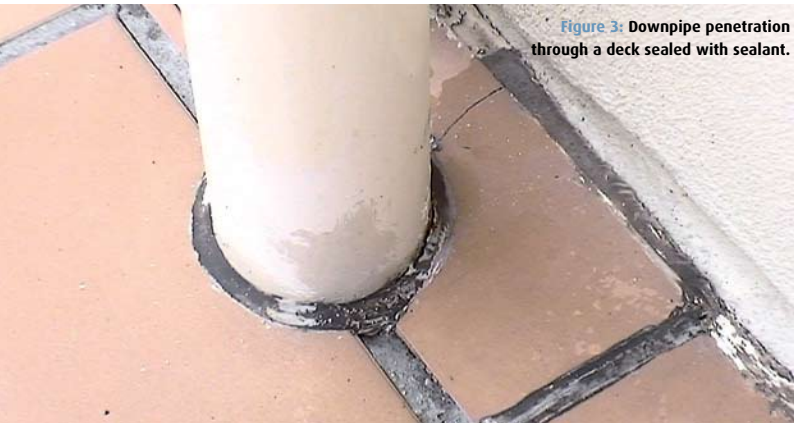
Often attempts are made to seal deck penetrations around the actual penetration using a sealant. **Figure 3** illustrates where this type of sealing has been used around a pipe penetration through a deck. **Figure 4** shows the result of water leakage in the soffit lining where a sealant was used around a downpipe penetration through a deck.

Figure 3: Downpipe penetration through a deck sealed with sealant.

The correct way of dealing with a deck pipe penetration is shown in **Figure 5**. This method allows the pipe to move vertically without compromising the waterproofing. The over flashing sealed onto the pipe moves with the pipe and the flanged up-stand is fixed to the deck substrate. It is important that there is clearance between the over flashing and the deck to allow for the vertical movement that is to be accommodated between the surface of the deck and the pipe.

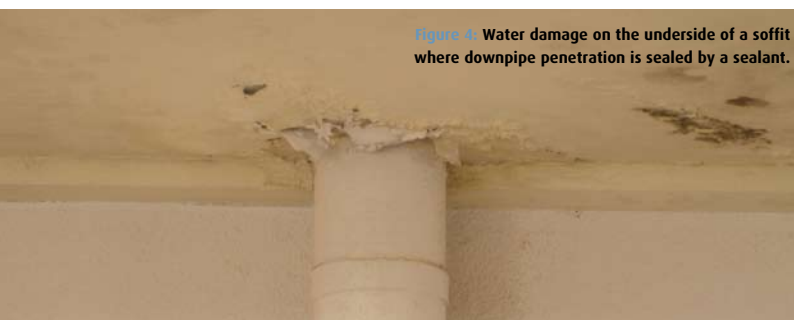
Figure 4: Water damage on the underside of a soffit where downpipe penetration is sealed by a sealant.

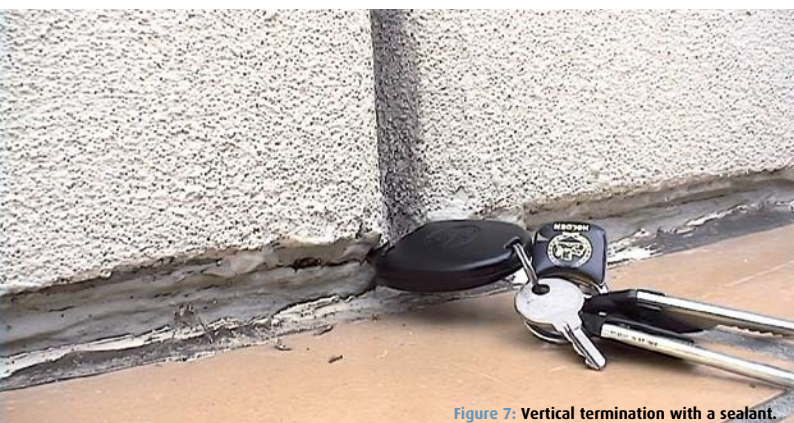
Figure 7: Vertical termination with a sealant.

The sealant fails due to the different temperature movements experienced on the horizontal surface in contrast to the vertical surface. The sealant fractures, as it cannot accommodate the longitudinal differential movement caused by different temperature movements at the junction. A typical example of the fracturing that occurs is shown in **Figure 7**.

I discussed temperature movement in Issue 52 of *Tile Today* (page 128) in regard to the waterproofing of lightweight decks. The best way to terminate at these surfaces is to turn up the membrane above the finished surface level of the deck. With solid construction this membrane turn-up can be bonded onto the horizontal and vertical surfaces with the use of a suitable bond breaker at the junction. With lightweight construction the membrane is bonded onto the horizontal surface and supported by an angle on the vertical surface. The extent of turn-up required depends on the exposure of the deck to wind-driven rain. In very sheltered conditions it can be as low as 30 mm. In extreme conditions it can be over 200 mm. In most low-rise residential construction a minimum of 50 mm is required. A typical termination of this type is shown in **Figure 8**.
