# Avoiding efflorescence through design and construction practices

**Colin Cass sets out the two main principles for avoiding staining from calcium build-up on external tiling.**

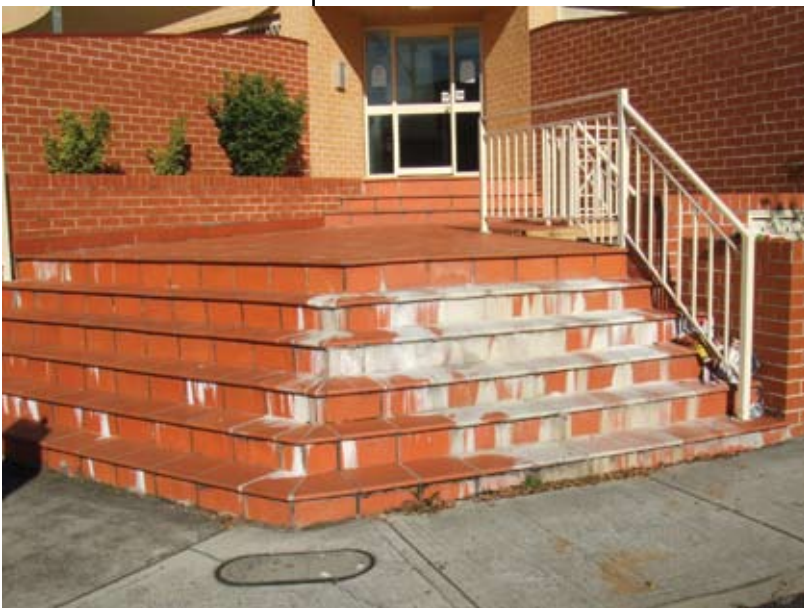
**Photo 1.** Secondary efflorescence with calcium carbonate forming on the surface of external stair tiling.

Secondary efflorescence – also known as leaching – occurs only when continuous or cyclical saturation of a cementitious material allows free lime or other salts within the masonry to be dissolved and to migrate to the surface (**Photo 1**). Secondary efflorescence can be very difficult to stop, and may continue to leach out of the masonry for many years. The avoidance tactics described here concern secondary efflorescence.

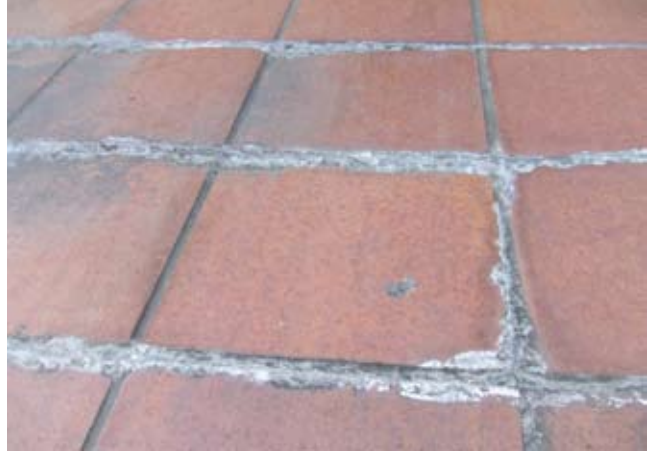
**Photo 2.** Efflorescence forming where moisture below the impervious tiles rises through cracks in the grout.

Any entry of rainwater to a building system will obviously follow the path of gravity, finding its way to the lowest point or exit. In walls, water may simply exit at the face or travel down to the floor. If a flooring substrate has a gradient down to an area where there is no outlet, then this area of the tiling screed will become saturated and act as the reservoir for this now salt-laden water. The salt solution will then rise to the surface of the tiling through a process of equilibration, because it is attracted to warmer or dryer atmospheric conditions. As the water evaporates, a calcium build-up will remain. If the tiled area is exposed to sunlight or warm conditions, it can act like a layer of plastic sheeting over an area of damp but seemingly dry concrete. Condensation will form on the undersides of the tiles and the natural movement of the moisture upwards through the tile joints will encourage efflorescence crystal growth along the tile joints and on the surface of the tiles (**Photo 2**).

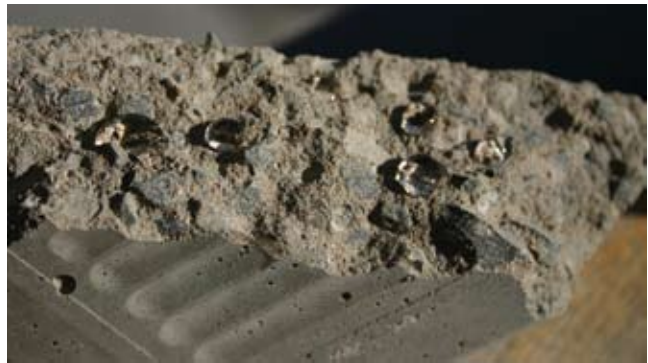
**Photo 3.** Concrete treated with a nanotechnology-based sealer repels water. Efficacy with friable mortars such as paving beds is not yet known.

The entry of water into the tile screed can be minimised by one of three methods: treating the cured tile screed with a liquid waterproofing penetrant that is compatible with both the membrane and the tile adhesive (**Photo 3**); applying a waterproofing membrane both under and over the screed; and/or sealing the surface of the tiles and grout joints with a penetrating water repellent (**Photo 4**).

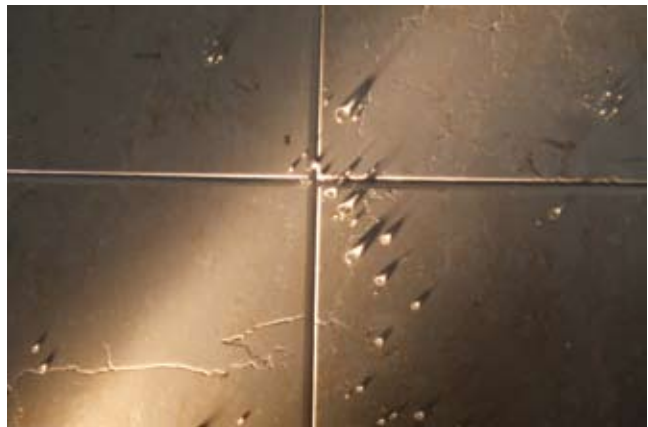
**Photo 4.** The application of a penetrating sealer prevents or minimises water penetration through the tiles and grout.

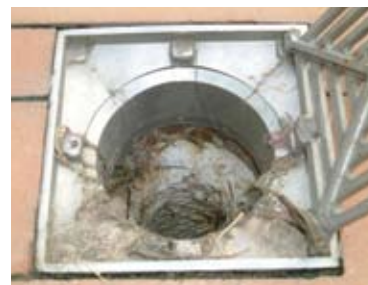
**Photo 5.** When the drain is open at the neck, and there is a gradient in the substrate to the drain, the efflorescence forms down the drain pipe and not on the tiles.

The best method of removing (salt-laden) water that has found its way into the mortar is to allow it to escape at the neck of any drainage grate or sump. In other words, do not seal the grate to the membrane without ensuring that there are weep holes in the side of the grate (Photo 5). The capacity of the drain must also be sufficient to allow easy evacuation of surface water, or water may re-enter the bedding system through the weep holes. Be aware that the diameter of the drain may decrease as salts build up in the pipe; this may require periodic maintenance.

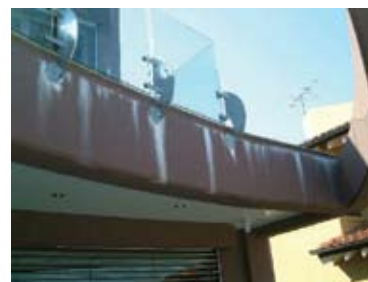
**Photo 6.** Where the gradient in the substrate leads to a free edge, efflorescence will form on the riser. To avoid this problem, seal a water-stop angle to the floor at the edge or one tile in from the edge, and grade the substrate behind the angle to a drain.

Substrate falls must not be allowed to go to a free edge (**Photo 6**) unless the salt-laden water is collected by a gutter, or the area is not going to be adversely affected by the appearance of efflorescence (such as in a garden bed).

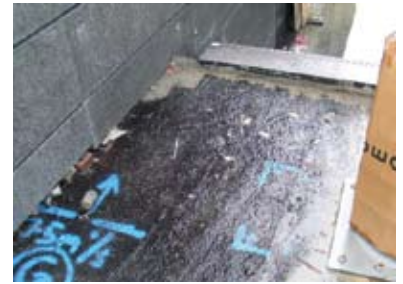
**Photo 7.** A gutter down the left edge of the stairs, which contains drainage cell material under the stone, will ensure that water from the landing takes that pathway and does not emerge through the stair risers.

Often on stairs, it is advisable to have a surface gutter run down the side with a drainage cell beneath it. This ensures that the only efflorescence that can form on the risers and treads is from the limited amount of calcium hydroxide available in the stair tiling (**Photo 7**). The drainage cell should be about 200 mm wide and should be laid plastic side up, with no joints at nosings.

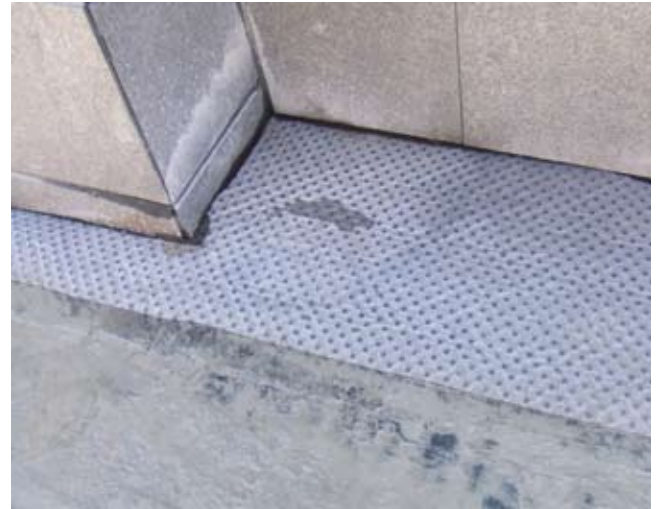
**Photo 8.** Drainage cell fabric under the tiling screed makes it easy to direct subterranean water to designated outlets.

As subterranean water will take the easiest path, in large areas or where large volumes of subterranean water are expected, strips of drainage cell material can be placed on the waterproofing, beneath the screed, to provide for easy movement of the water to the designated outlet (**Photo 8**).

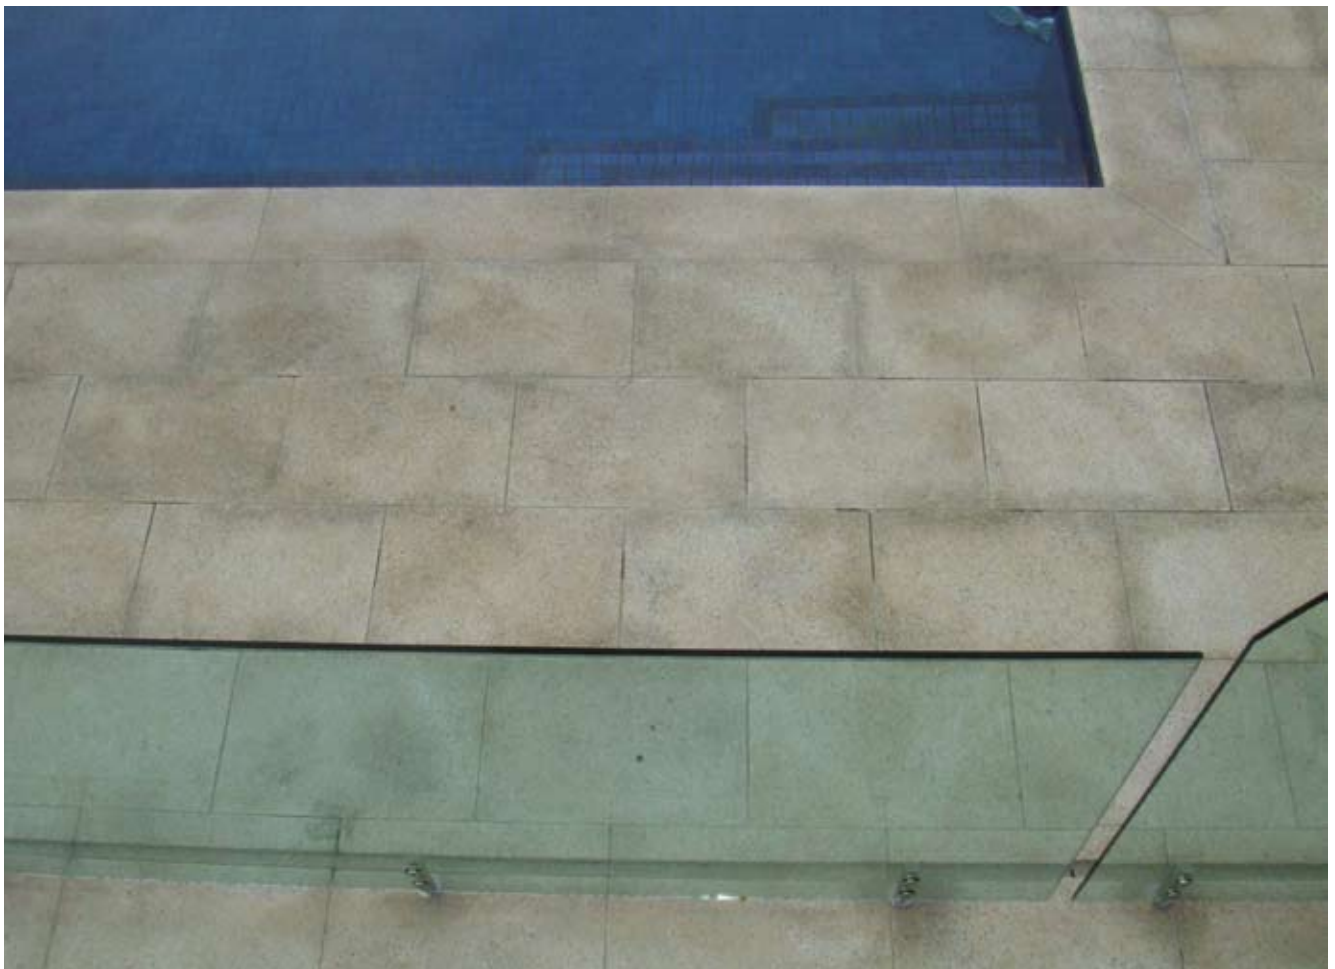
**Photo 9.** Efflorescence has formed inside this granitic stone and it is now irremovable. Pre-sealing the back of the stone with a specialist solution could have avoided this problem.

Some igneous stone, particularly absorbent granitic products, can become permanently discoloured when efflorescence crystals form inside voids in the stone (**Photo 9**). The best method to prevent this discolouration is to pre-seal the back and edges of the stone 24 hours before laying. Pre-sealers usually have a potassium methylene silicate base, which is very different to the silane siloxane base of common penetrating sealers. Unlike normal sealers, pre-sealers will not interfere with the bonding of cement or adhesive to the back of the stone.
