SEALING DECKS EDGE TERMINATIONS AND PENETRATIONS

By Barry Schafer

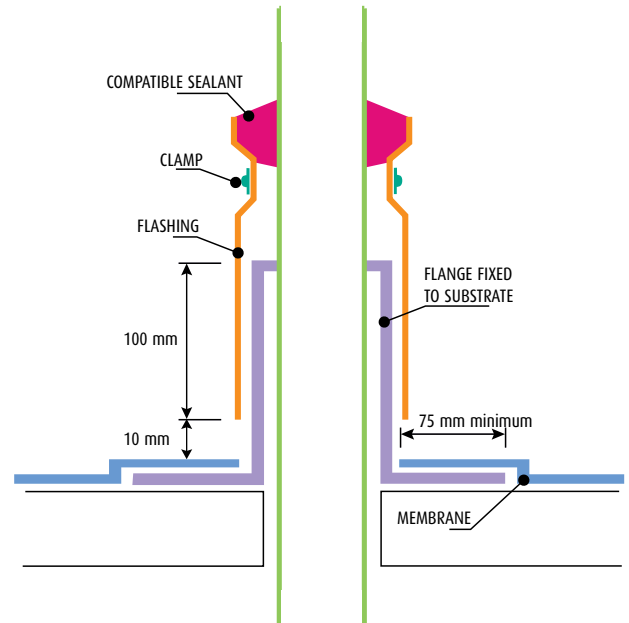
Often attempts are made to seal deck penetrations around the actual penetration using a sealant. **Figure 3** illustrates where this type of sealing has been used around a pipe penetration through a deck. **Figure 4** shows the result of water leakage in the soffit lining where a sealant was used around a downpipe penetration through a deck.

Figure 4: Water damage on the underside of a soffit where downpipe penetration is sealed by a sealant.

The correct way of dealing with a deck pipe penetration is shown in **Figure 5**. This method allows the pipe to move vertically without compromising the waterproofing. The over flashing sealed onto the pipe moves with the pipe and the flanged up-stand is fixed to the deck substrate. It is important that there is clearance between the over flashing and the deck to allow for the vertical movement that is to be accommodated between the surface of the deck and the pipe.

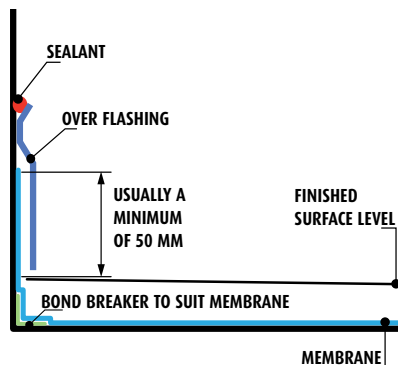
Figure 8: Typical edge termination at a vertical surface.

I discussed temperature movement in Issue 52 of *Tile Today* (page 128) in regard to the waterproofing of lightweight decks. The best way to terminate at these surfaces is to turn up the membrane above the finished surface level of the deck. With solid construction this membrane turn-up can be bonded onto the horizontal and vertical surfaces with the use of a suitable bond breaker at the junction. With lightweight construction the membrane is bonded onto the horizontal surface and supported by an angle on the vertical surface. The extent of turn-up required depends on the exposure of the deck to wind-driven rain. In very sheltered conditions it can be as low as 30 mm. In extreme conditions it can be over 200 mm. In most low-rise residential construction a minimum of 50 mm is required. A typical termination of this type is shown in **Figure 8**.
