Stone in the built environment – a guide to specifying limestone tiles

By Jim Mann, Principal of Stone Initiatives and a director of the ASAA

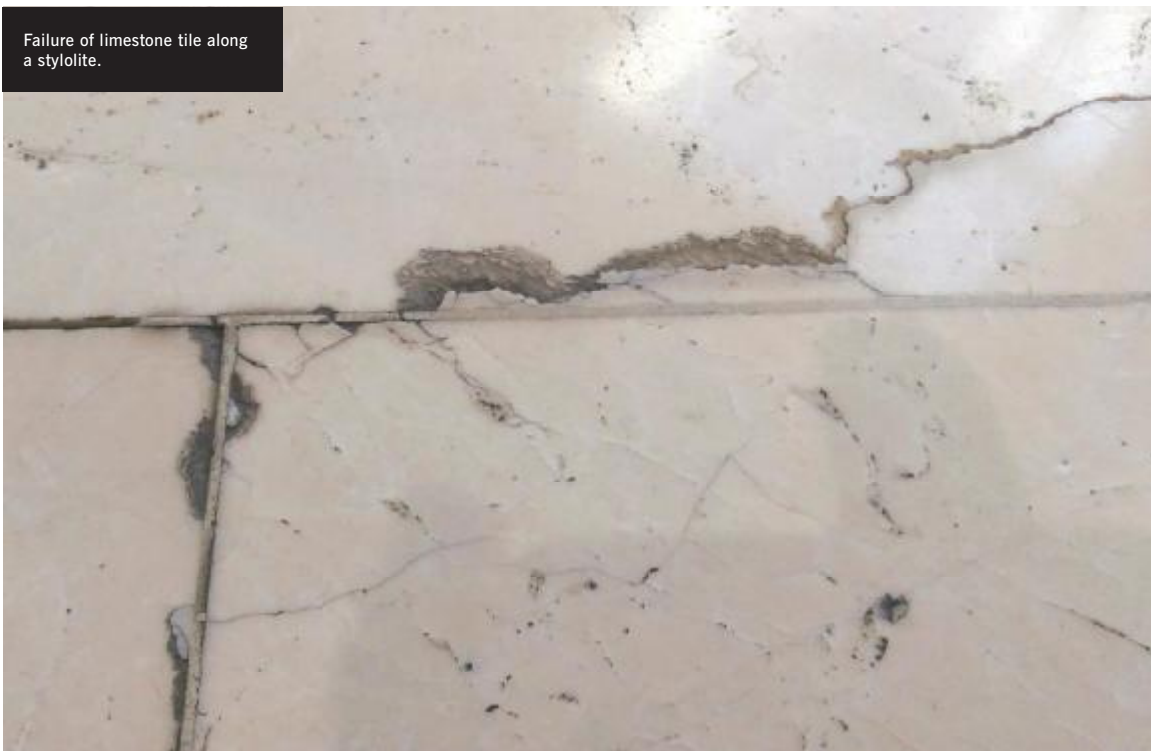
Fine stylolite can be seen traversing across the surface of a tile.

presents as spalling. This spalling is usually due to detachment of flakes of stone along features called stylolites, which appear as fine, zig-zagging veins on the surface of the tile.

Stylolites develop at pressure-dissolution boundaries, where insoluble minerals within the stone (e.g. clay) accumulate. The development of these planar features usually results in the formation of clay-lined veins and micro-porosity; as a result, there is a localised increase in water absorption capacity. This increase in water absorption can cause a reaction between the clay and moisture, the consequence of which can be a reduction in strength and durability.
